**ANNUAL REPORT
FOR THE
ROCKY FLATS ENVIRONMENTAL TECHNOLOGY SITE
GROUNDWATER PLUME TREATMENT SYSTEMS
January through December 2003**

January 31, 2005

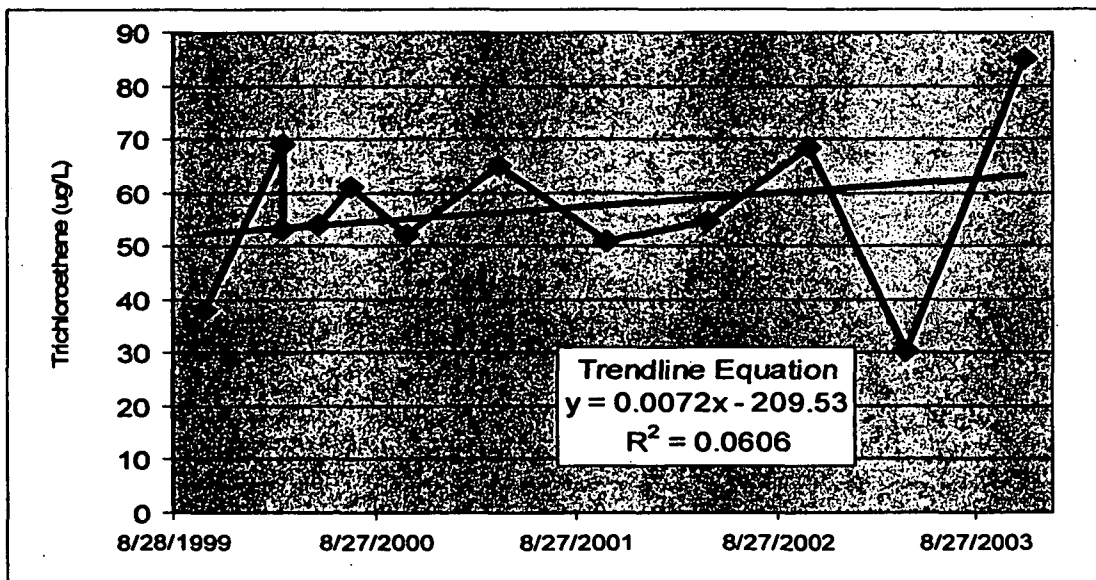
Figure 8. Trichloroethene Concentration in Well 95199

Well 95199 is downgradient of the collection system and upgradient of Pond B-2. Figure 8 shows the concentration of trichloroethene in Well 95199 over time. No other contaminants are

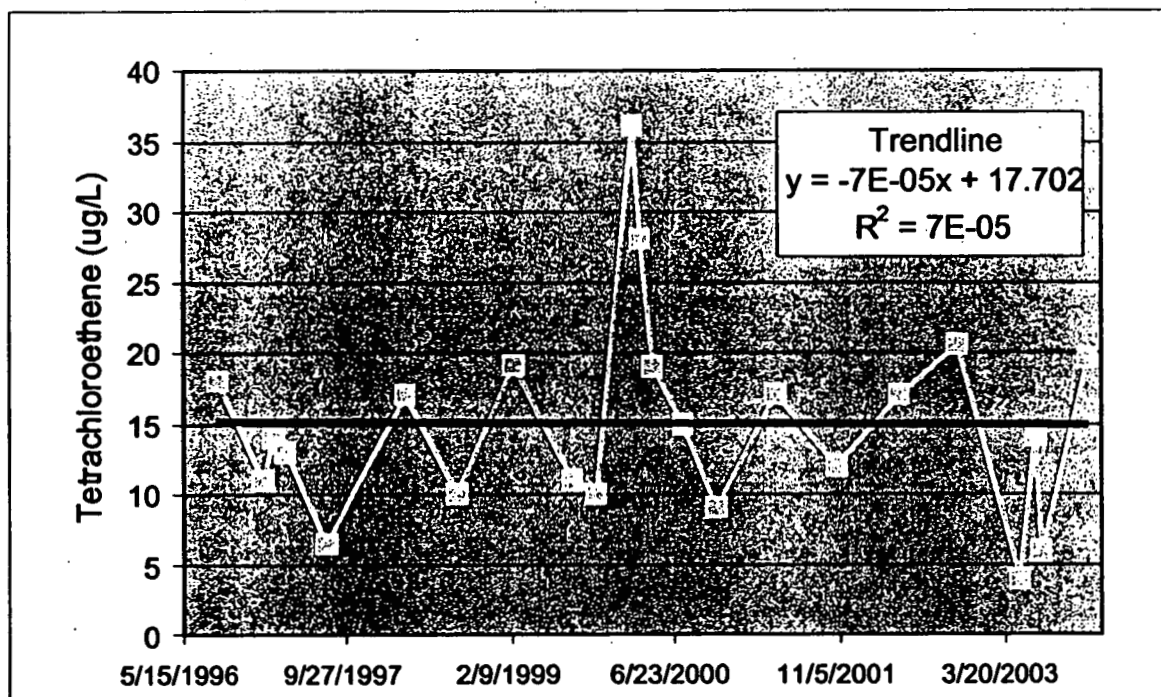
Figure 11. Historical Tetrachloroethene Trend in Well 23296

Well 23296 is located near Pond B-3, where the East Trenches Plume discharges to surface water. Higher VOC concentrations observed at this well were an early indication that a remedial action should be considered for this plume. As can be seen in Table 11, VOC concentrations at Well 23296 exceed RFCA Tier II ALs. In the past, VOC concentrations also exceeded Tier I ALs at this well.

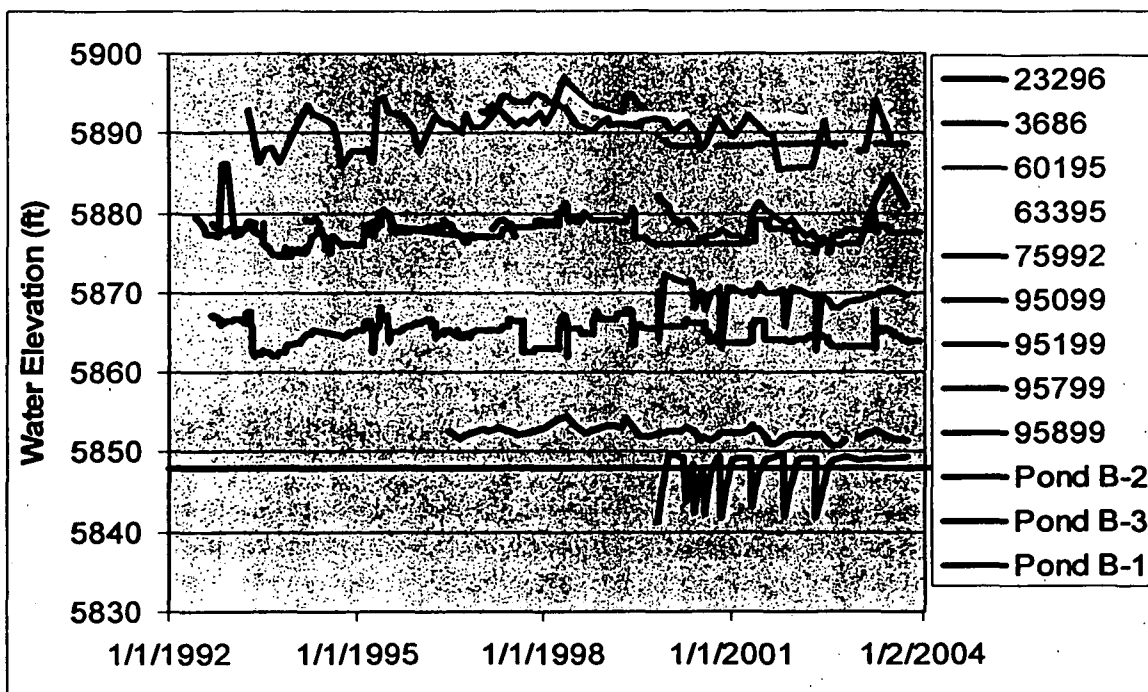
Figure 13. East Trenches Plume System Water Elevations

Three wells are immediately downgradient wells of the collection trench and one well is located to the east and downgradient of the collection trench (Figure 7). These wells continue to demonstrate that there is a strong gradient downward to the northeast. Well 95299 is always dry, providing evidence that there is no groundwater flow from the ponds or from groundwater bypassing the trench in this area.

Well 23296 is adjacent to Pond B-3 and shows less water level fluctuation probably because its water level is dominated by the water levels in Pond B-3. Pond B-3 pond water is held at a near constant elevation by its discharge pipe.

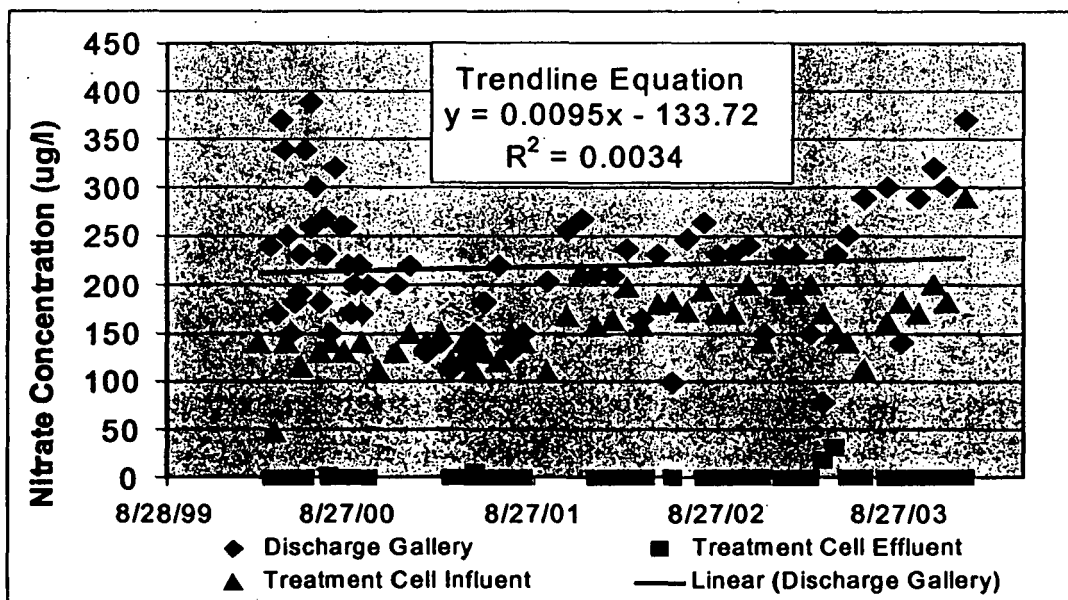
Figure 15. Solar Ponds Plume Treatment System Nitrate Concentrations

Figures 15 and 16 show nitrate concentrations and uranium activities since the system was installed. Influent and discharge gallery nitrate concentrations appear to be increasing. Uranium in the discharge gallery also appears to be increasing.

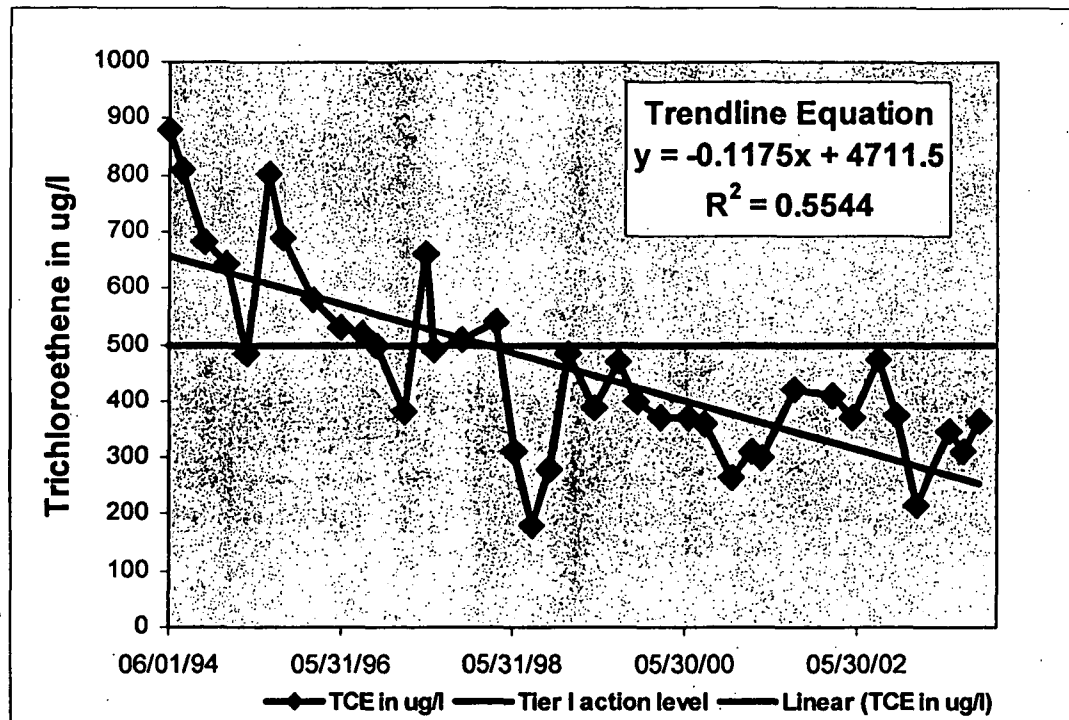
Figure 21. Trichloroethene Concentrations in the OU1 Collection Well

The Collection Well continues to be sampled quarterly. The 2003 VOC analytes that are above detection limits are provided in Table 19. Figure 21 shows the trichloroethene concentrations in the collection well relative to time and the overall downward trend. Trichloroethene and other contaminants continued to remain below the RFCA Tier I Groundwater ALs throughout the year.

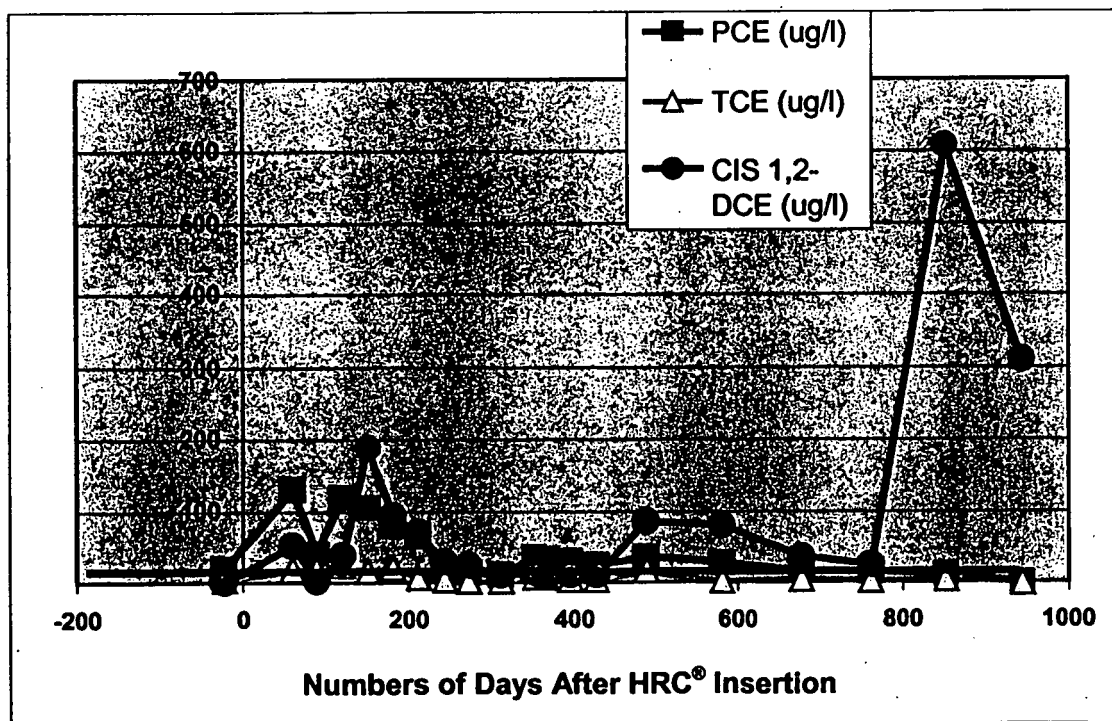
Figure 25. Tetrachloroethene and Degradation Products Concentration versus Time in Well 31001

It was anticipated that this downward trend would continue; however, the cycle repeated itself when the water table rose again in the spring of 2002 and again in the spring of 2003 (Table 24). In both 2001 and 2003 the water table rose close to ground surface. As the water table rises, contaminants present in the vadose zone are liberated, causing an increase in groundwater contaminant concentrations.

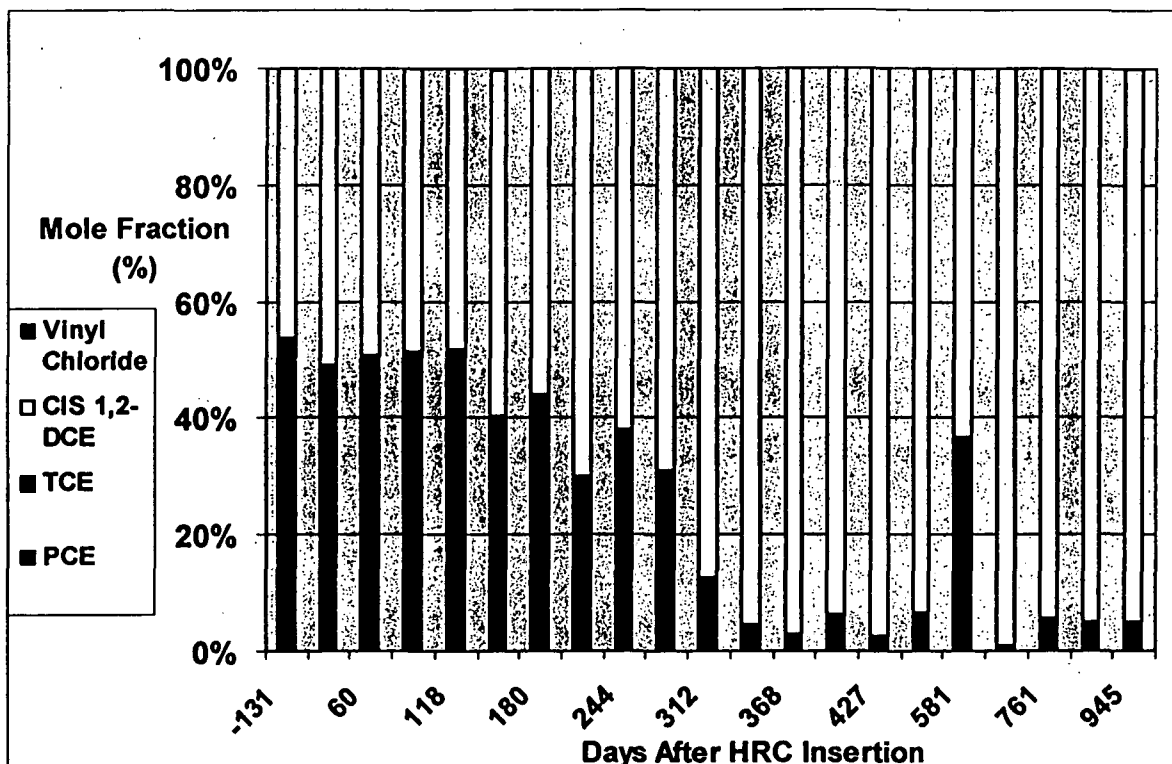
Figure 27. Mole Fraction Percent of Tetrachloroethene in Source Area Well 30900 Relative to its Degradation Products Over Time

Initial increases in concentrations after HRC® and when the water table rises indicate that VOCs are being transferred from the soil to an aqueous phase, potentially accelerating both soil and water remediation. Typically, the VOCs trapped in the saturated and vadose zones have been the most difficult phase to remediate and continue to act as a contaminant source. Since these are being mobilized and then biologically degraded along with contaminants in the dissolved phase, this is a much more robust treatment methodology than simply biologically degrading the dissolved fraction or DNAPL pools below the water table.

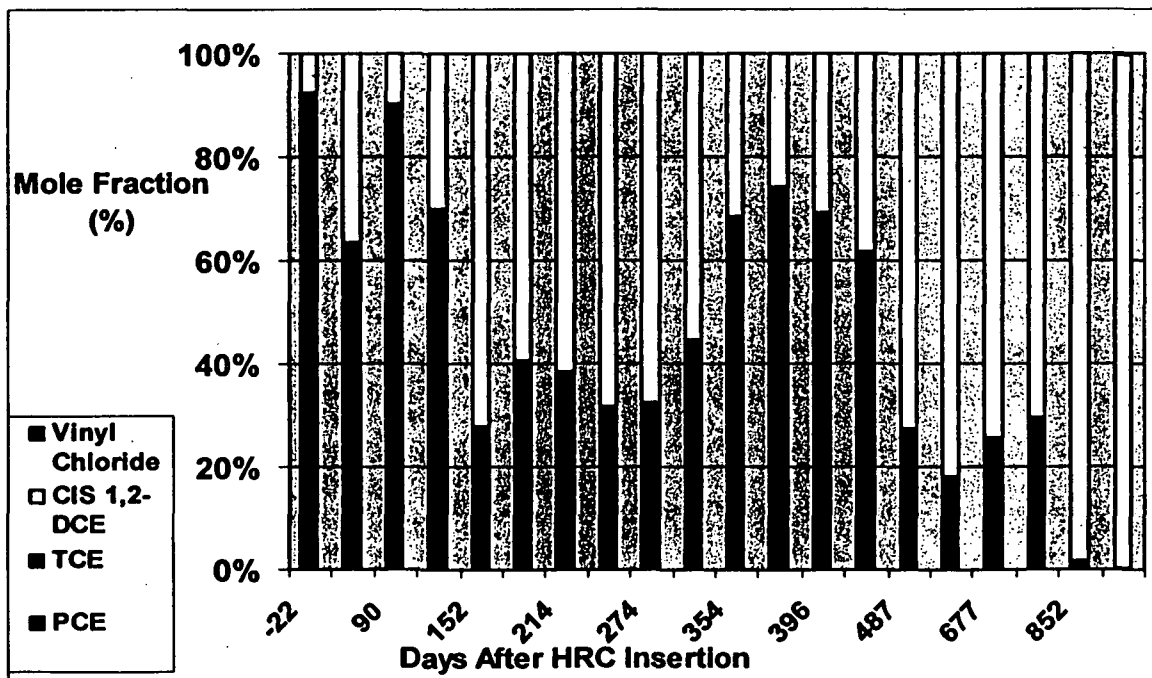
Figure 28. Mole Fraction Percent of Tetrachloroethene in Downgradient Well 31001 Relative to its Degradation Products Over Time

As shown in Table 23, the presence of other degradation products such as trans 1,2-dichloroethene, 1,1-dichloroethene, vinyl chloride, and ethene demonstrates that degradation is occurring because these contaminants were not associated with releases at the PU&D Yard. The increase in the ratio of degradation products relative to tetrachloroethene concentrations also confirms that degradation is occurring. Figures 28 and 29 show this increase in degradation products over time.
